## Clarification of Mechanism of Shinkansen Derailment in the 2011 Great East Japan Earthquake and Countermeasures Against Earthquakes

Kenji Horioka

Director, Safety Research Laboratory, Research and Development Center of JR East Group

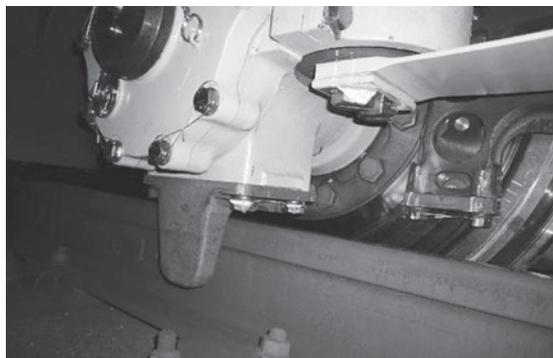
Fig. 1 Derailed Wheel  
(viewed from front on right side of inbound train)

A train (series E2, 10-car train set) on a test run had departed the Shinkansen Depot north of Sendai and was passing through Sendai Station at 72 km/h when the emergency stop system activated the emergency brakes. The train received strong swaying force due to the earthquake when decelerating, the No. 1 and No. 2 axles of the bogie in the direction of Tokyo on Car 4 derailed to the left at approx. 14 km/h, and the train stopped after traveling a further approx. 2.6 m. In this situation, deviation prevention car guides at the right side of the No. 2 axle of the bogie contacted the rail, controlling deviation to the left.

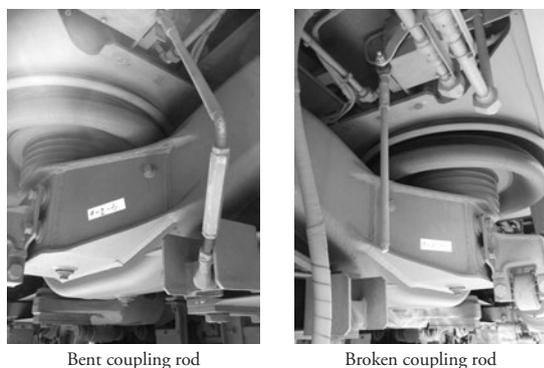
For cars, the damage particularly at the bogies and carbody suspension system was damage to air spring level controlling valve coupling rods due to rolling behavior of the cars, damage to pistons of active suspension lateral dampers, and remarkable deformation of attachment for the lateral displacement stopper rubber bogie-side due to the body center pin forcibly striking the lateral displacement stopper rubber.

Fig. 4 Case Example of Damage to Air Spring Level Controlling Valve Coupling Rods due to Rolling Behavior of Cars Affected by Seismic Motion

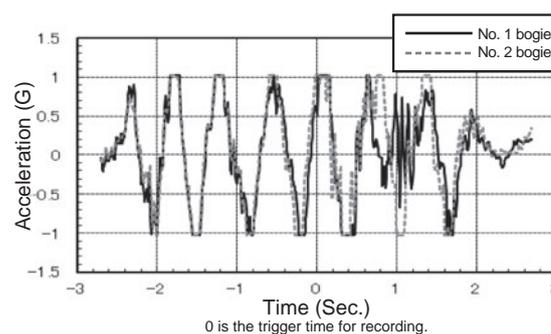
The car's active suspension lateral dampers have a failure recording function, and upon reading that out there was a record of acceleration of  $\pm 1$  G at around 1.5 – 1.6 Hz as shown in Fig. 5, backing the results of response analysis on the viaduct as mentioned in 4.1. And from car kinematic analysis, we can estimate the lateral force that acted on the axles and force that acted on the lateral displacement dampers. This backs the findings that tremendous force widened the gauge due and deformed and damaged the bogies and carbody suspension systems.

Fig. 5 Acceleration Record at Earthquake for Active Suspension Lateral Dampers of Derailed Car (Upper limit of recording is  $\pm 1$  G. Peaks greater than that are not shown on the graph.)

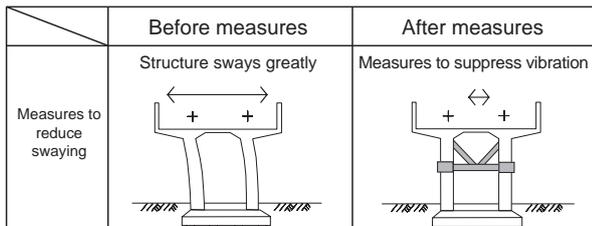
The report by the Japan Transport Safety Board also mentions that the guides performed well, but it also states the need for measures to prevent reoccurrence of such derailment. Specifically, it states that it would be desirable to scrutinize vibration properties of the location of the derailment and, if necessary, take measures on resonance and the like upon verifying their effects.

Fig. 7 Measures for Location of Derailment (Image)

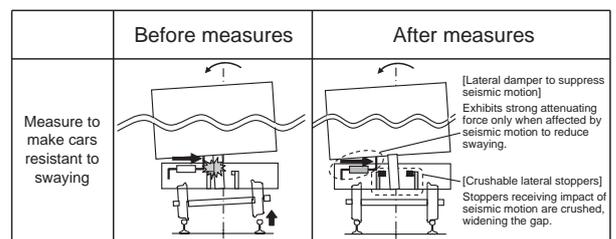
Fig. 8 Measures to Make Rolling Stock Affected by Seismic Motion Resistant to Derailment

In measures for rolling stock, R&D is underway for methods of making cars more resistant to derailment even under larger swaying. Attenuating vibration centering on rolling behavior of car bodies as shown in Fig. 8 is effective in keeping in check derailment of rolling stock affected by seismic motion. We

discovered from car kinematic analysis the effectiveness of increasing the attenuating force of lateral dampers between the bogies and body or, if rolling behavior cannot be suppressed, widening the stopper gap to suppress strong lateral force generated by the body center pin striking the bogie. As a result of those discoveries, the Railway Technical Research Institute (RTRI) is developing lateral dampers to suppress seismic motion and crushable lateral displacement stoppers, both of which have such functions to make cars more resistant to derailment. JR East plans to study assessment of lateral dampers as countermeasures against seismic motion on rolling stock with a goal of practical implementation of those.
