Improvement and monitoring of Miyanaka Intake Dam fishway structure for harmonization of hydropower and river environment

There were two problems in the fishway located in the right-bank side of the Miyanaka Intake Dam of the middle reaches of the Shinano River. The 1st problem was due to the continuity of the fishway entrance downstream part was not secured, and the 2nd problem was due to the flow of the pool is unstable. About the 1st of dam problem by, repeating numerical analysis and a local discharge experiment and finding out real almsgiving and the optimal discharge pattern was found. The validity was checked by run-up course check investigation of the salmon. About the 2nd problem, the hydraulic model experiment and the field trial were done, while improving the large-sized fishway to the ice harbor type, the "Seseragi fishway" was newly established by considering biodiversity. By being checked run-up species during the monitoring investigation, after reconstruction than before, improvements of the fishway was confirmed. As part of adaptive management in the fishway structural improvement project it is planned to continue monitoring further.

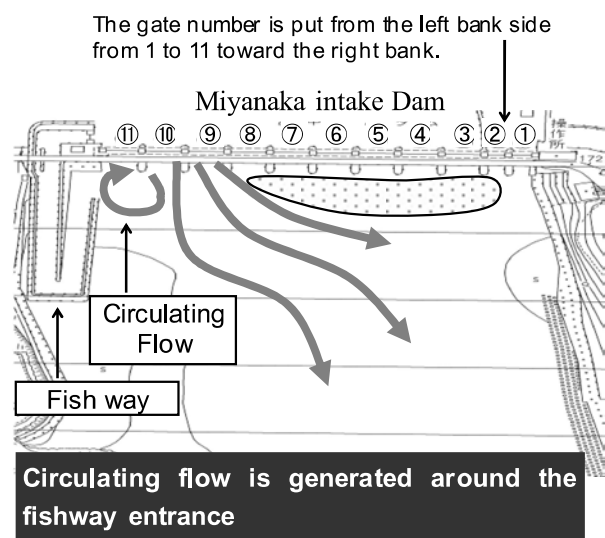
Fig.3.Discontinuity of Miyanaka Intake Dam downstream

Since fishway of a Miyanaka Intake Dam was installed in the right-bank side, it was difficult for fish because to run-up principal current which was formed at the left-bank side was reached at the entrance of

fishway. The circulating flow had generated in the vicinity of the fishway entrance by that gate discharge. (Fig. 3)

The 1st step means a discharge method from the gates No.9 and No.10 of the right bank side, the 2nd step means an effect of improving the flow around the fishway entrance by discharge from the gate No.11 of the edge of the right bank, and the 3rd step means a method of discharge from the gates from No.6 to No.11.(Fig. 5)

- The pattern that makes the discharge of the gates No.9 and No.10 the same is reasonable.
- It is unsuitable to enlarge the discharge from the gate No.11 too much.

- As for an appropriate discharge method of the gate No.11, it should be controlled under the amount of discharge rather than the pattern, and suitable range is around 12-15m³/s.

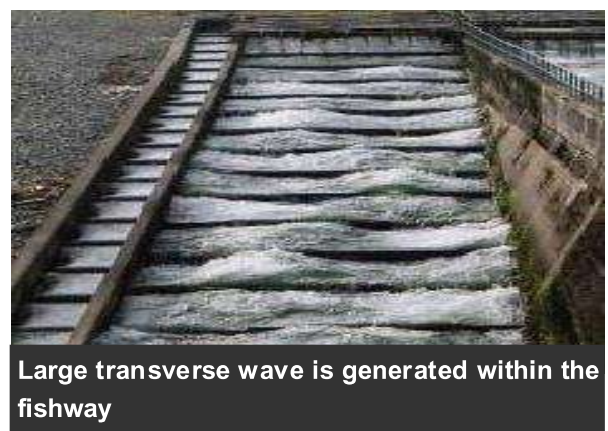
Fig.4. Unstable flow in the fishway

Due to the shape of the pool was oblong, notch and orifice were alternately prepared. The flow of the pool was complex. Transverse wave was generated according to flow rate. (Fig. 4)

In order to decrease the complex flow in the pool that originated in the oblong plane shape of the pool with the alternate arrangement of notch and orifice, measures were necessary to the fishway for larger fishes. Therefore, the width of the fishway was reduced from 10m to 8m, improving to the Ice Harbor type fishway.

- The Ice Harbor type that reduces the fluctuation of water surface is adopted.
- The turning pool is established like the semicircular shape.

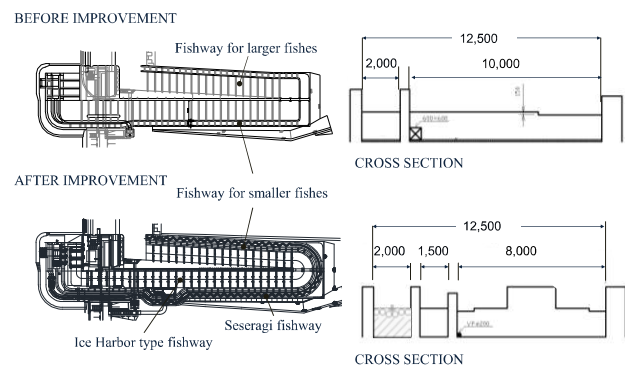
Fig.7. Outline of the improvement plan of the fishway structure

About the fishway for smaller fishes, the current shape was transferred since desirable flow was experienced on the existing fishway, and the grade of upstream migration was excellent in the investigation. (Fig.7 , Table 2)

To achieve migrating environments of various species of fishes including the bottom fishes and fishes with small swimming ability, a small size fishway with natural rough stones was set up newly. In addition to two lanes of the existing pool and weir type fishways. In this paper, the

The brooklet fishway was designed by 25cm in width like the meander in the existing channel of the fishway for smaller fishes, and its slope is 1/20.
