# FEATURE 1: GREAT EAST JAPAN EARTHQUAKE: HOW WE MANAGED TO RESTORE THE TOHOKU SHINKANSEN LINE IN JUST 49 DAYS

### RESTORATION OF THE TOHOKU SHINKANSEN LINE

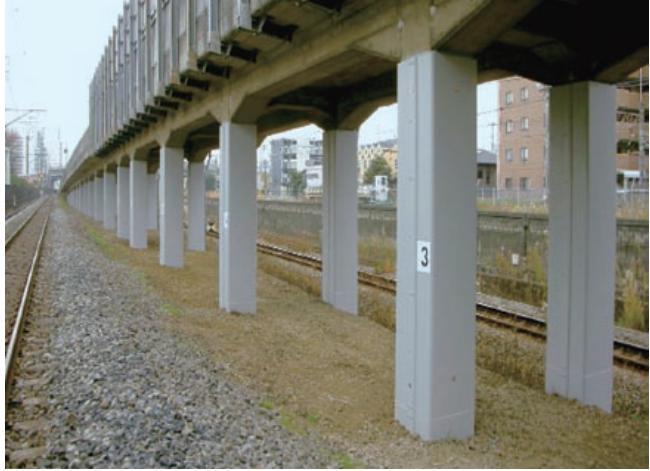
Aseismatic reinforcement (Yokosuka Line, between Musashi-Kosugi and Shin-Kawasaki)

In fiscal 1996, the company commenced emergency aseismatic reinforcement work on viaduct columns susceptible to shear failure, and by fiscal 2001 had completed work in the southern Kanto, Sendai and other areas.

Following the Sanriku-Minami Earthquake, which struck in May 2003, the geographical scope of aseismatic reinforcement measures for viaduct columns was broadened, and after the Niigata Chuetsu Earthquake of October 2004, work also commenced on bridge piers. As a consequence, aseismatic reinforcement for shearcritical viaduct columns and bridge piers was completed a year ahead of schedule for the entire Shinkansen lines of JR East in fiscal 2008, and for the conventional lines in the Southern Kanto region, Sendai and other areas by fiscal 2009.

Since fiscal 2010 we have undertaken a project approximately five years in length for a second round of aseismatic reinforcements with a view to further improving safety when an earthquake strikes. Among viaduct columns of the type susceptible to flexural failure in areas such as southern Kanto and Sendai, we identified those likely to sustain damage in a powerful earthquake, and undertook reinforcement measures to jacket steel plates around the columns.

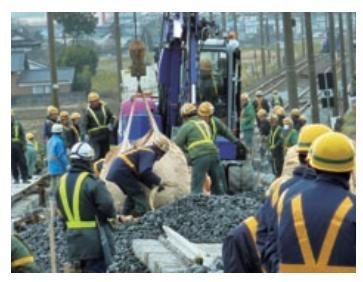
Restoration work on the Joban Line
