## Basic Study on Shear Failure Behavior by Shear Rebar Used as Seismic Reinforcement of Underground RC Structures

In order to provide underground RC structures with seismic reinforcement, JR East is developing a construction method whereby shear rebars are added from drilled holes because the ground around the structure prevents reinforcement from outside. One possible method of installing shear rebars to underground RC structures afterward at low cost is to use large-diameter rebars. However, this method requires careful consideration of the anchorage length and shear reinforcement effect if such large-diameter rebars are used. Assuming use of large-diameter rebars for wall members, we studied failure behavior based on shear failure tests using beam specimens at their actual cross-section height and three-dimensional nonlinear FEM analysis. The results clarified that failure occurs and develops due to bond deterioration at the end of large-diameter rebars.

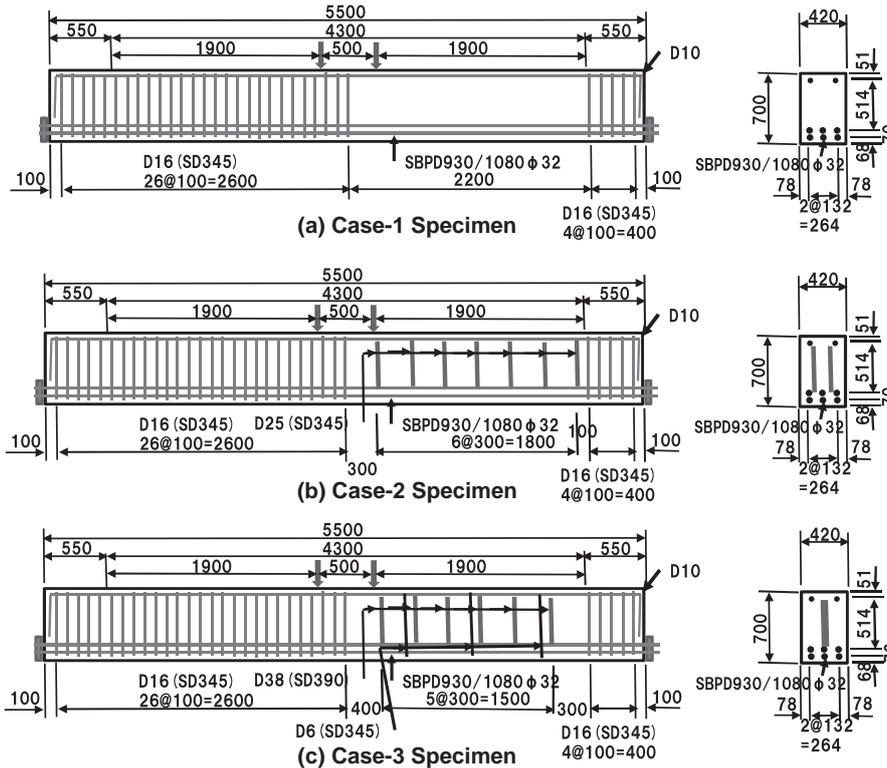
Fig. 1 Detailed Diagrams of Specimens

Table 1 shows the specifications of the specimens, and Fig. 1 shows their shapes.

We used three test specimens of the cross-sectional dimensions 420 mm  $\times$  700 mm. The cross-section height was 700 mm and the effective height around 600 mm, similar to the height of members for ordinary culverts. The shear span was 1,900 mm and the shear span ratio ( $l_a/d$ ) around 3.0. Each of the three specimens failed on the side from the loading point to the movable support point and was reinforced on the side from loading point to the fixed support point. As reinforcement, D16 (SD345) shear rebars were placed at intervals of 100 mm to prevent shear failure. The object of this experiment was to clarify the shear failure area.

Case-1 was a basic specimen without shear reinforcement. Case-2 was a specimen with D25 shear rebars in two rows at intervals of 300 mm. The 300 mm interval was decided as around a half of the effective height ( $d$ ), the maximum interval of shear rebars stipulated in design standard and the like for RC structures.

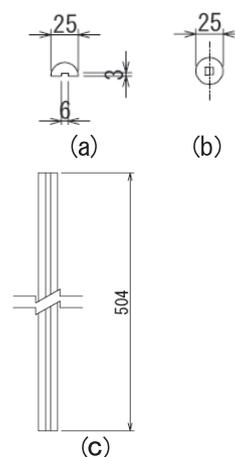
Fig. 2 Production Drawing of D25 Rebar

another D25 rebar of the same lot that was split in the same manner to make a single shear rebar. Fig. 2 shows a processing drawing of the D25 shear rebars used for the Case-2 specimen. (a) in the figure is the processing dimensions, (b) is the cross-section of the bonded rebar, and (c) is the entire length. Fig. 3 is a photo of the rebar being processed.

For Case-2, D25 shear rebars were used. We split a rebar in two lengthwise and milled a slot on each of the rebar halves to attach a strain gauge inside. We then bonded that rebar to

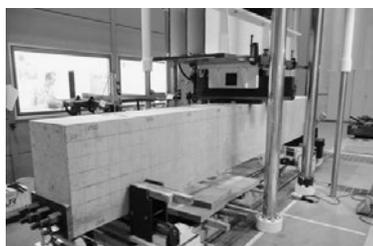
Fig. 4 Loading Test

Fig. 4 shows testing being performed. The tests were bending tests at four points. The load was removed until near zero when flexural cracking was visually observed, and then it was gradually applied again to around 50 kN until the specimens being broken. The purpose of removing the load once when flexural cracking occurred was to check the fitting level of the loading plate and the support plates.

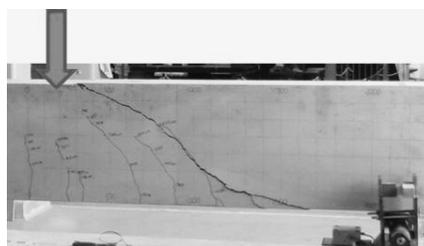
Fig. 5 Failure of Case-1

Fig. 5 shows the failure of Case-1. As we found no compressive failure of concrete around the loading point, we determined the failure mode to be diagonal tensile failure.

With Case-1, flexural cracking occurred at the edge of the area of uniform bending with loading of 231 kN. Then, as the load increased, the number of the flexural cracks also increased. With around 350 kN loading, cracking at approx. 700 mm from the loading point in the direction of the support point (at the point about 1.2 times of the effective height  $d$ ) changed to diagonal cracking. With 450 kN loading, diagonal cracking that started from the point approx. 950 mm from the loading point in the direction to the support point (at a point about 1.58 times effective height  $d$ ) extended to a point approx. 200 mm from the upper edge. With around 480 kN loading, the diagonal cracking reached the vicinity of the loading point, and as soon as the 485 kN maximum load was recorded, the diagonal cracking went through near the supporting point and the load sharply dropped.

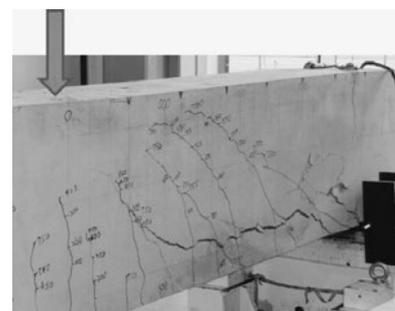
Fig. 6 Failure of Case-2

The diagonal cracking that extended close to the upper edge was almost completely stopped by the longitudinal cracking, and it looked closed at the end. We determined the failure mode of Case-2 to be flexural failure because the cracks that bypassed the shear rebars and entered the uniform bending area caused crushing of the concrete on the upper edge. Fig. 6 shows the failure of Case-2.

With 600 kN loading, the cracking at approx. 600 mm, 800 mm, 1,100mm, and 1,300 mm from the loading point to the direction of the support point developed into diagonal cracking. With 750 kN loading, the end of the diagonal cracking that started from the point approx. 1,000 mm from the loading point in the direction to the support point reached a point approx. 80 mm from the upper edge. As the load increased and exceeded 800 kN, cracking in the longitudinal direction of the specimen occurred near the upper surface of the longitudinal rebars. With further loading, the cracking along the longitudinal bar changed its direction, at the support point to the upper edge of the uniform bending area, and then the concrete near the upper edge of the uniform bending area was crushed. The load at crushing was 892 kN.

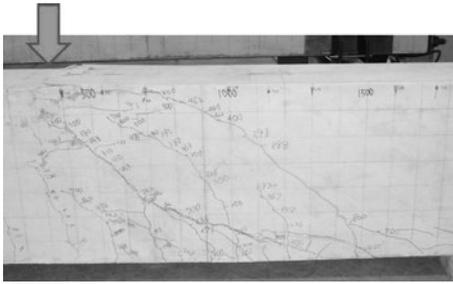
Fig. 7 Failure of Case-3

Fig. 7 shows the failure of Case-3. As the cracking that started from a point approx. 750 mm from the loading point extended close to the loading point and the load capacity of the specimen was lost with crushing of the upper edge concrete, we determined the failure mode to be compressive shear failure.

With Case-3, flexural cracking occurred with 140 kN loading. With around 300 kN loading, flexural cracking that started from the point approx. 600 mm from the loading point in the direction to the support point (at a point approx. 1.0 times effective height  $d$ ) turned into diagonal cracking. With 400 kN loading, the flexural cracking at the lower edge approx. 450 mm, 500 mm, 750 mm, and 1,250 mm from the loading point in the direction to the support point turned into diagonal cracking. With 500 kN loading, the end of the diagonal cracking that started from a point approx. 1,250 mm from the loading point in the direction of the support point extended to the point approx. 50 mm from the upper edge. As the load was increased to 600 kN, the end of the diagonal cracking reached a point approx. 50 mm from the upper edge. Then, development of cracking that reached the neighborhood of the upper edge almost completely stopped even with further loading, while development of other diagonal cracking was observed.

With 800 kN, the diagonal cracking that started from the point approx. 750 mm from the loading point in the direction of

the support point extended in the direction of the loading point. As loading continued, the upper edge near the loading point was crushed, and the load dropped.

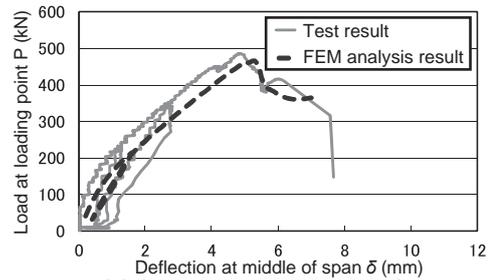
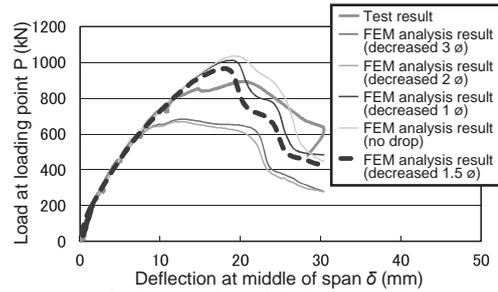
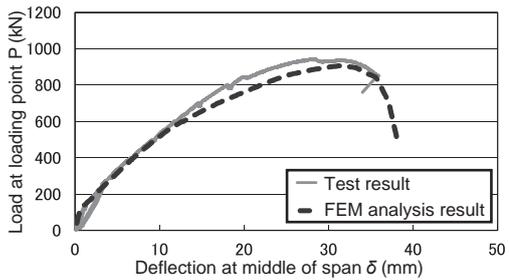
Fig. 8 Load-Deflection Curves of Individual Test Specimens

Fig. 8 (a) to (c) show the load-deflection curves of the three specimens as test results. The load-deflection curves of the analysis results, which will be explained later in Chapter 4, are also shown in the figure. The load is the full weight at the loading point, and the deflection is the perpendicular deflection at the middle of the span. The perpendicular deflection at the middle of the span at which the maximum load was recorded was 5 mm with Case-1 (basic specimen), 20 mm with Case-2 in which flexural failure occurred, and 30 mm with Case-3 in which compressive shear failure occurred.

Fig. 8 (a) to (c) are the load-deflection curves from the analysis results.

The analysis results of the Case-2 specimen with a rebar ineffective area of 1.5  $\phi$  indicates relatively good consistency to the actual test results. With the Case-3 specimen, overall analysis results were well consistent to the test results.

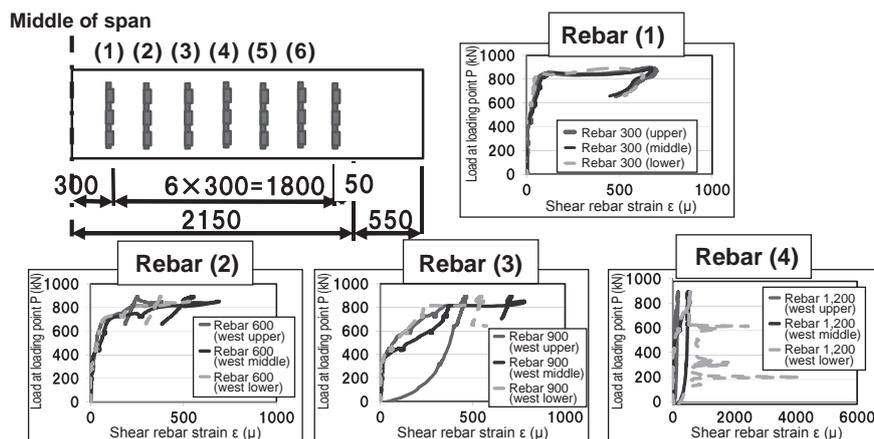
Fig. 9 Occurrence of Strain in Case-2 Specimen Shear Rebars

Fig. 9 shows the occurrence of strain on the shear rebars of Case-2 and Fig. 10 shows that of Case-3. In Fig. 9 and 10, the horizontal axis is the strain of the shear rebars and the vertical axis is the load at the loading point.

With the Case-2 specimen using D25 (SD345) shear rebars, the strain on those rebars located within 900 mm from the middle of the span was around 700 to 800  $\mu$  (rebars (1) to (3)). The strain on the rebar at 1,200 mm from the middle of the span

(rebar (4)) was 500  $\mu$  with maximum loading, and it reached the yield strain when the load dropped to 75% of the maximum load. The maximum strain on that rebar reached as high as 4,000  $\mu$ .

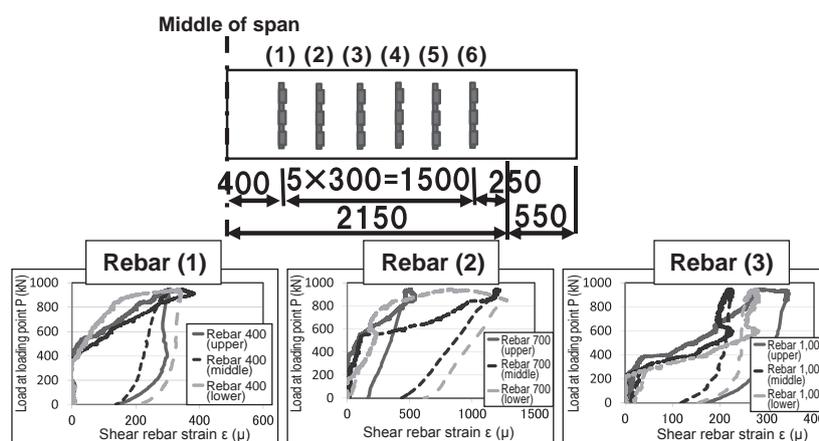
Fig. 10 Occurrence of Strain in Case-3 Specimen Shear Rebars

With the Case-3 specimen using D38 (SD390) shear rebars, the maximum strain on those rebars was around 1,200  $\mu$ . This was measured with a strain gauge attached to the middle of that rebar at 700 mm from the middle of the span (rebar (2): at 400 mm from the loading point). As the yield strain on D38 (SD390) rebar is 2,372  $\mu$ , about half of the yield strain occurred.

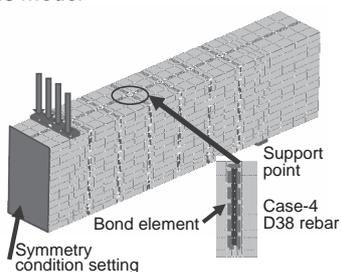
Fig. 11 FEM Analysis Model

Fig. 11 shows the analysis model used in this analysis. Based on the symmetry, we applied a half-scale model. The applied constitutive law was the 3D extended RC planar model. The original RC planar model was based on the material composition model that took into account arbitrary loading path dependency, which was developed by the concrete laboratory of the University of Tokyo.

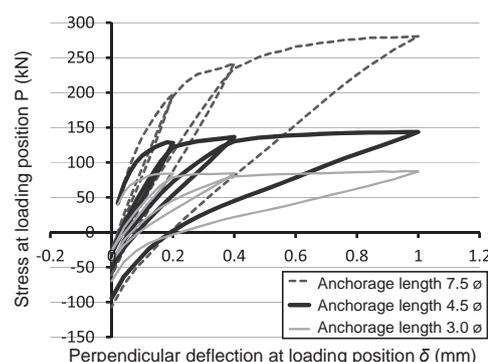
Fig. 12 Bond Properties Given to D38 Rebars

In analysis of Case-3, we placed D38 shear rebars as the rebar elements. Around the D38 rebars, we placed bond elements that expressed properties of bonding to concrete. The bond strength of those bond elements was the calculated value of the bond strength formula indicated in the reference documents<sup>9)</sup>. To check the bond behavior of the rebars with bond elements, we first conducted analysis by making the rebar placement the same as that of Case-3 and varying anchorage length of the rebars.

The anchorage lengths were 7.5 times, 4.5 times, and 3.0 times the rebar diameter ( $\phi$ ) respectively. For analysis, we applied forced deflection from the upper end of the rebar elements. Deflection was around the volume of dimensionless yield slippage (dimensionless slippage at the time of rebar yield of 0.03, pullout displacement of 1.0 mm) based on the reference documents.<sup>10)</sup> The tensile strength at yielding for the D38 (SD390) rebars used for the Case-3 specimen was 465.2 kN; but with the anchorage length of 7.5  $\phi$ , remarkable slippage between the rebars and concrete was observed at around 220 kN, about half of the rebar yield strength. Taking into account that the strain of D38 rebars obtained in the tests was around a half of their yield strain, we judged the bond properties of the rebar were largely appropriate, so we used those results in the analysis.

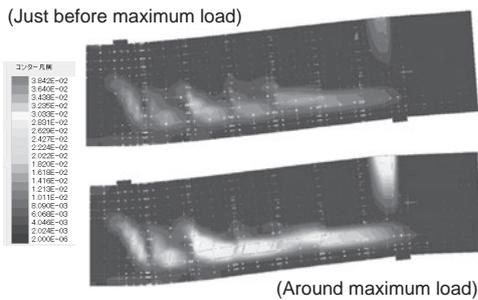
Fig. 13 Results of Case-2 Specimen Failure Behavior Analysis

Fig. 13 shows the principal strain distribution of the analysis results of the Case-2 specimen just before and at around the maximum load. As the analysis shows, diagonal cracking occurred followed by cracking along the main rebar. And then failure shifted to the upper edge above the middle of the span, resulting in flexural failure.

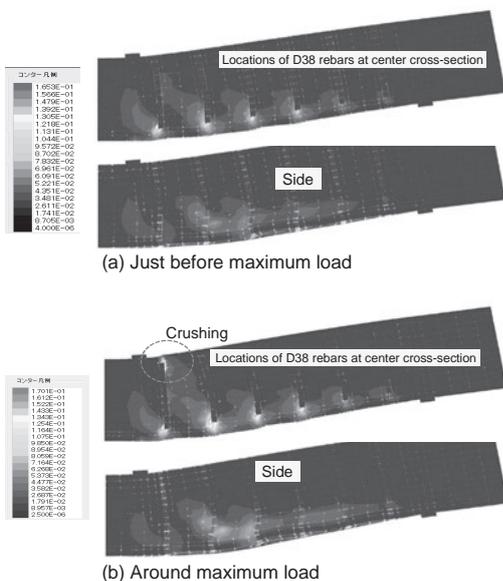
Fig. 14 Results of Case-3 Specimen Failure Behavior Analysis

Fig. 14 (a) and (b) show the principal strain distribution as the analysis results of the Case-3 specimen. Fig. 14 is the analysis results of the side surface and of the middle of the cross-section surface where rebars were located. As shown in Fig. 14 (a), just before the maximum load, the bond at the lower end of the D38 rebars (near the longitudinal rebars) began to be lost. As shown in Fig. 14 (b), at around the maximum load, the D38 rebar slipped at its upper end near the loading point, increasing the principal strain at the upper edge, and finally concrete was crushed. At that time, upper edge concrete was not yet crushed on the side surface. Further increase of deflection enlarged the crush area of the upper edge concrete, causing sharp decrease of the load. Based on those analysis results, we concluded that the slippage of large-diameter rebars at their end caused crushing of the Case-3 specimen.
