# Primary Damage Caused by Niigata Chuetsu Earthquake

Date: October 23, 2005 (Saturday) at 17:56  
 Seismic center: East longitude 138 deg. 52 min. 12 sec.  
 North latitude 37 deg. 17 min. 18 sec.  
 Magnitude: 6.8. (Level: 7 on the Japanese Intensity Scale)

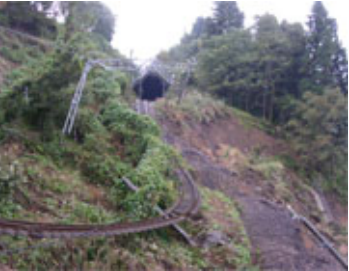
Embankment Collapse (Shin-Etsu Line)

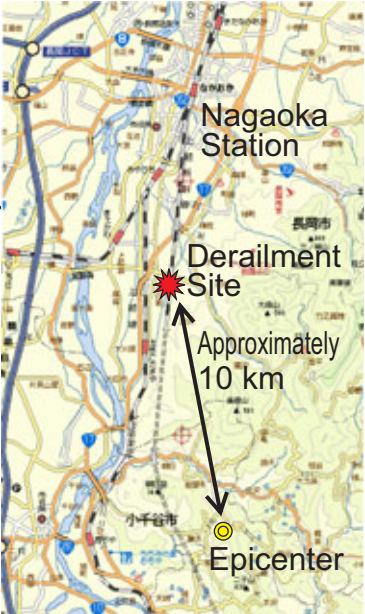
Derailment (Joetsu Shinkansen)
