## Development of Beams for Sections Susceptible to Salt Damage

Tadashi Yoshida\*

Beams that support overhead contact lines in sections susceptible to salt damage corrode fast and need to be replaced before reaching their expected service life. We have thus developed beams with high anticorrosion properties for those sections. First, aiming to improve corrosion prevention performance, we carried out salt water spray tests for three types of materials on which double rust prevention was applied. The tested materials were zinc hot dip galvanized steel + saturated polyester powder coating, zinc hot dip galvanized steel + ceramic coating and weather-resistant steel + epoxy resin coating + polyurethane resin coating. Test results demonstrated that saturated polyester powder coating was superior. Then, we made prototype beams of steel pipe coated with saturated polyester powder. Those prototype beams are now undergoing long-term durability testing in Omigawa Station on the Shin-etsu Line. Since the average decrease of coating thickness is as small as  $19 \mu\text{m}/\text{year}$ , we expect that this type of beam will not require replacement for 60 years, the standard replacement inte

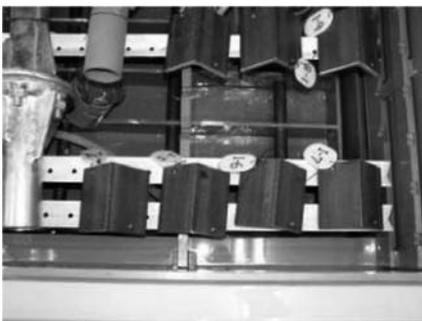
In order to determine the age in the field equivalent to an eight-hour cycle (spraying salt water for two hours, drying for four hours, then moistening for two hours), we carried out salt water spray tests using untreated steel pieces shown in Fig. 2. We calculated ages equivalent to each cycle based on the amount of corrosion of the pieces.

Fig. 2 Test Pieces for Age Calculation

To find the amount of corrosion per 50 cycles, we used 11 test pieces in total and evaluated the amount of corrosion after salt water spray tests. To evaluate corrosion, the corroded pieces were

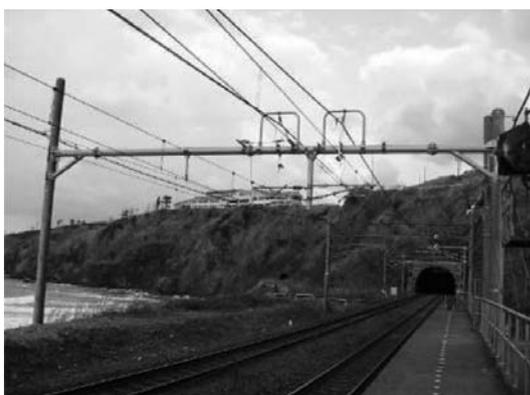
As we confirmed that double rust prevention by zinc hot dip galvanized steel + saturated polyester powder coating to be effective in corrosion prevention, we made prototype beams and installed them on-site. The test site selected is Omigawa Station on the Shin-etsu Line, which is in a section near the coast susceptible to salt damage. Fig. 13 shows the installed prototypes. Installation could be done in the same time amount of time as with existing zinc galvanized steel pipes.

Fig. 13 Installed Beams for Sections Susceptible to Salt Damage
