Measures taken since the accident on the Uetsu Line

We would like to report the measures we have taken after the derailment accident of the limited express train Inaho No. 14 between the Sagoshi and Kita-Amarume stations near the No.2 Mogamigawa Bridge on December 25, 2005.

Measures after the Niigata Chuetsu Earthquake

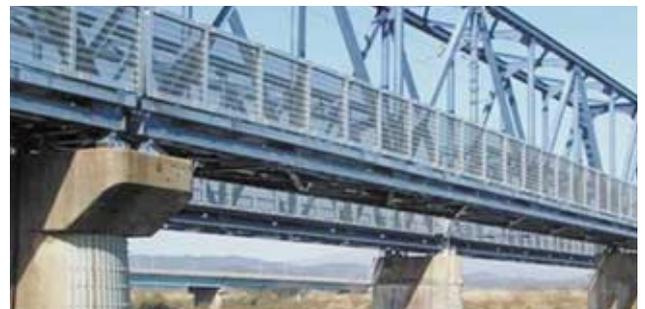
Windbreak fence installed at the No.2 Mogamigawa Bridge

To reduce the forces exerted on trains by wind, we decided to construct windbreak fences at 11 locations, including the site of the Uetsu Line accident between Sagoshi and Kita-Amarume stations (the No.2 Mogamigawa Bridge) and similar locations on the Keiyo Line between Kasai Rinkai Koen and Maihama stations. For locations where windbreak fences were installed, we changed the op-

erating restrictions due to wind to the general restrictions shown in the foregoing table. These changes take the reduction of wind forces into account.

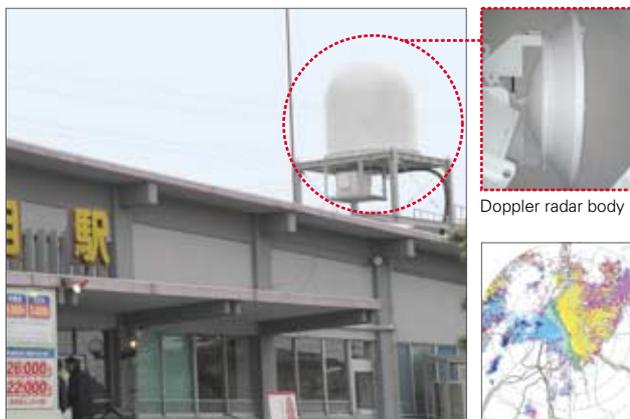
Doppler radar installed on the roof of Amarume Station on the Uetsu Line

Sample image from a Doppler radar

In January 2007, we installed a Doppler radar at the Uetsu Line Amarume Station and started test observations from February 2007. Doppler radar can determine wind conditions by detecting the movements of raindrops and rain clouds. It is used at some airports for detecting local gusts. However, since this is the first time that Doppler radar has been applied for monitoring local gusts for a railway, we are collecting and analyzing the data to develop ways of utilizing the radar for decision-making in train operation.
