Article

Quantifying Vegetation on a Rock-Ramp Fishway for Fish Run-Up and Habitat Enhancement: The Case of the Miyanaka Intake Dam in Japan

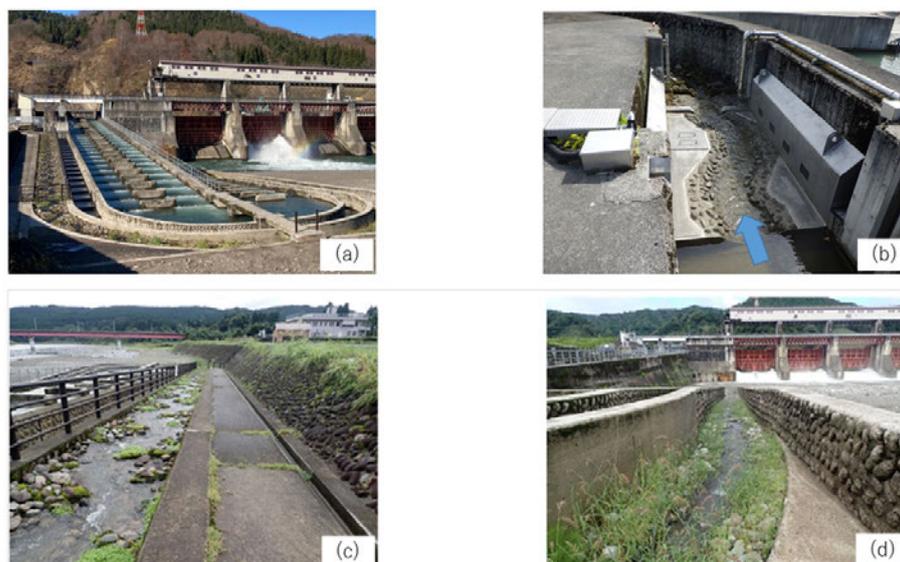
Figure 1. Photos of Miyanaka Intake Dam: (a) dam and fishway from the downstream side, (b) a sector gate at the upstream end of the rock-ramp fishway; the dam end of the sector gate rises by 0.5 m when flooded or when needed for maintenance, the blue arrow indicates the direction of flow, (c) rock-ramp fishway and the revetment on the right bank side from the upstream side of the dam, (d) the turn-around section of the rock-ramp fishway from the downstream side.

Figure 1a shows the dam and fishway from the downstream side. There are three fishways on the right bank side, and the main flow downstream of the dam is on the left bank side. The large fishway has been improved to an ice-harbor type by narrowing the width from 10 m to 8 m. The small fishway moved in parallel to the vacant 2 m site with the stair-type fishway. The rock-ramp fishway was newly established on the site of the stair-type fishway. A sector gate installed upstream of the rock-ramp fishway keeps the inflow of water constant (Figure 1b). In addition, since the sector gates are closed during floods, the inflow and deposition of sediment from upstream are suppressed. Figure 1c shows the rock-ramp fishway and the revetment on the right bank side from the upstream side of the dam. The channel of the rock-ramp fishway has a meandering shape to reduce the gradient. As shown in Table 1, the underwater cross section is trapezoidal (water surface width 0.7 m, bottom width 0.25 m, slope gradient 1:1.5) to change the water depth and flow velocity in the channel. The area was flooded for the first time by the largest recorded flood in the area due to Typhoon Hagibis in 2019. Figure 1d shows the turning part of the rock-ramp fishway from the downstream side when discharge was about $60 \text{ m}^3 \text{ s}^{-1}$. This area is flooded relatively frequently due to flooding of $1500 \text{ m}^3 \text{ s}^{-1}$ occurring once a year.

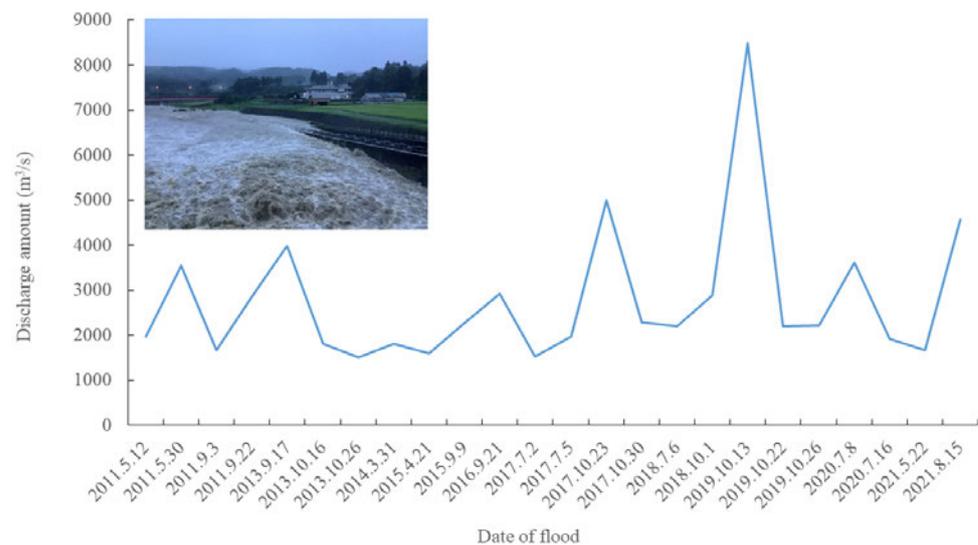
Figure 2. Records of discharges of over $1500 \text{ m}^3 \text{ s}^{-1}$ from 2011 to 2021. The photo shows the situation of approximately $4500 \text{ m}^3 \text{ s}^{-1}$ discharge at the time. The curved section of the fishway was clearly submerged.

Regarding flood history (Figure 2), a flood of about $4000 \text{ m}^3 \text{ s}^{-1}$ occurred between the 2013 and 2014 surveys. In October 2019, there was a flood of about $8400 \text{ m}^3 \text{ s}^{-1}$, which was the largest in recorded history (the second largest was about $7400 \text{ m}^3 \text{ s}^{-1}$, which occurred in 2008). In July 2020, between the June and September surveys, there was a relatively large flood of approximately $3600 \text{ m}^3 \text{ s}^{-1}$.

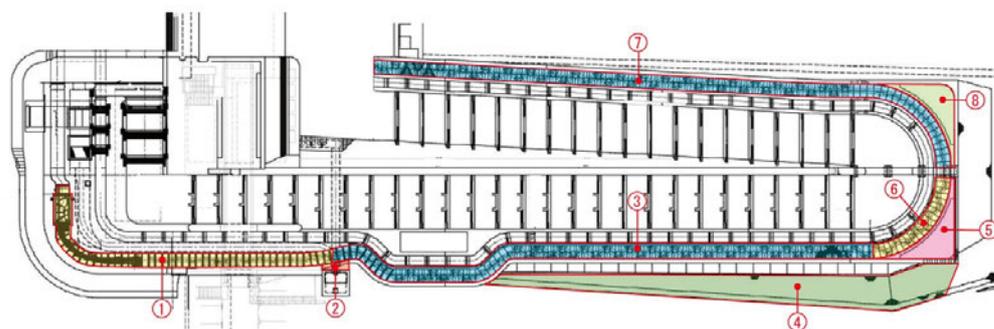
Figure 3. Scope of the vegetation survey. Area numbers were assigned from the upstream side on the left side of the Miyanaka Intake Dam. Areas 1, 3, 6, and 7 were set in the rock-ramp fishway, and Areas 2, 4, 5, and 8 were set around the rock-ramp fishway. Due to the discharge of the maintenance flow rate ($40 \text{ m}^3 \text{ s}^{-1}$), it was always flooded up to the middle of Area 7.

The rock-ramp fishway areas were divided into the following four categories with respect to sediment accumulation (Figure 3). Area 1 was a reach, with a $1/200$ gradient slope, where sediment did not accumulate, even during floods. Area 3 was a section where sediment was deposited during flooding of more than $5000 \text{ m}^3 \text{ s}^{-1}$, which occurred once every few years. In these reaches, the channel bed remained covered with the original rocks, with some fine sediment accumulating between them. Area 6 was a curved zone; thus, some sediment was relatively easily deposited during floods of $3000 \text{ m}^3 \text{ s}^{-1}$ or more. In the downstream reach (Area 7), sediment was deposited every year in cases of more than $1500 \text{ m}^3 \text{ s}^{-1}$ flooding.

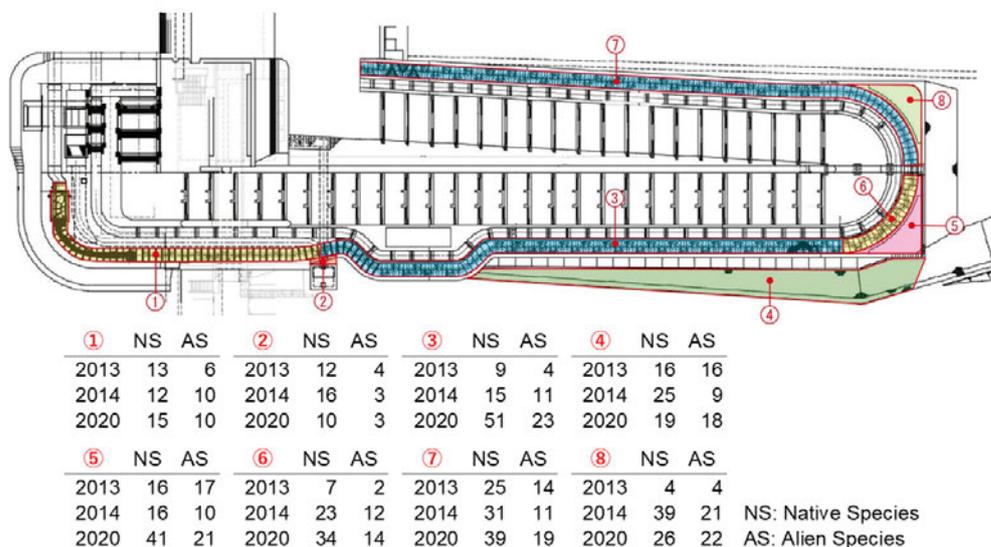
Figure 4. Number of native and alien species in each area based on the survey results of 2013, 2014, and 2020.

Table 2 shows the results of the vegetation characteristics. Over the survey period, the number of native species in the entire area increased from 64 to 97 species (67.4% to 66.9%) and alien species increased from 31 to 48 species (32.6% to 33.1%). The proportion of alien species was slightly higher compared with the Japanese average, which is around 20% [75]. They are shown by areas in Figure 4. Figure 5 shows the changes in vegetation in each area

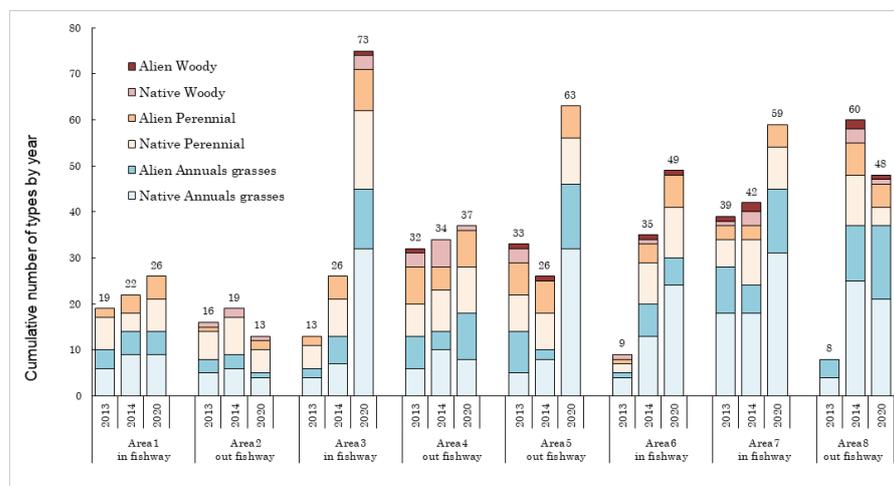
Figure 5. Variation in the cumulative number of different types of vegetation of each survey area based on their lifestyle characteristics.

The number of confirmed species increased slightly in most areas except for Area 2 (Figure 5). In the area inside the rock-ramp fishway, numerous species and growing individuals were confirmed near the turning part of Areas 6 to 7. In contrast, in Areas 1 and 3, the growth of plants was sparse. One of the factors that caused such differences in the growth conditions of each area was the presence or absence of a substrate for plants to take root. In the area near the turn of the rock-ramp fishway, the slope of the fishway was gentle, and sediment sometimes accumulated due to flooding. Therefore, sediment was deposited in the gaps between the rocks, and many plants, including the annual *P. thunbergii* and the perennial *Phalaris arundinacea*, could grow on the ground.

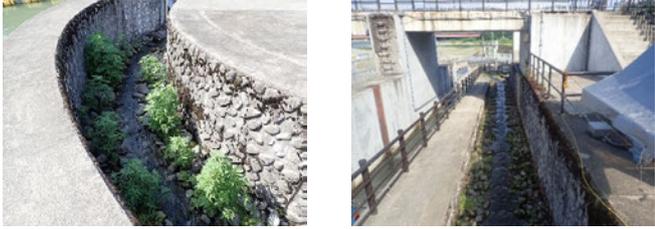
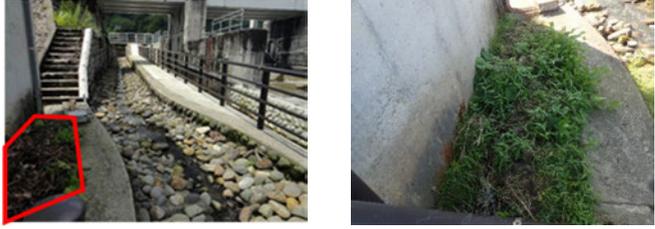
<p>Area 1 (30 m²): The annuals <i>Eclipta prostrata</i> and <i>Bidens frondosa</i> were sparse. On the upstream side, <i>B. frondosa</i> grew densely between rocks; however, it decreased in fall 2020. In inundated zones, an alien submerged species, <i>Elodea nuttallii</i>, colonized in 2020.</p>

<p>Upstream side Inundated zone</p>	<p>Area 2 (1 m²): <i>Persicaria lapathifolia</i>, <i>Bidens. frondosa</i>, <i>Petasites japonicus</i>, and <i>Morus australis</i> grew sparsely, and after artificial logging in the summer of 2020 only short plants generally remained.</p>

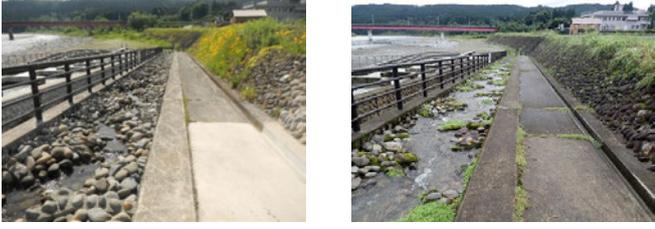
<p>2013 summer 2020 summer</p>
<p>Area 3 (45 m²): In 2020, <i>Sedum sarmentosum</i>, <i>Bidens frondosa</i>, <i>Elodea nuttallii</i>, and <i>Equisetum arvense</i> colonized this area following the new sediment deposition and seed settlement from the 2019 heavy floods. Important species and specific alien species were also confirmed.</p>

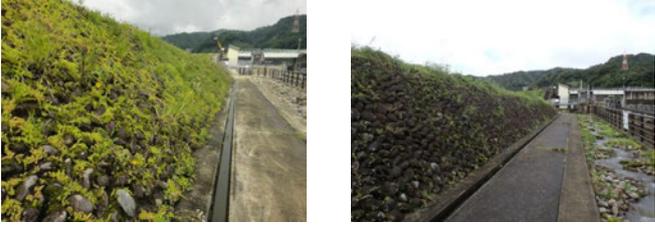
<p>2014 Summer 2020 Autumn</p>	<p>Area 4 (30 m²): Maintenance was applied until 2019, due to which the gaps in the masonry were filled with mortar. Many species such as <i>Coreopsis lanceolata</i>, a specific alien plant, were depleted. Then, a colony of <i>Galium gracilens</i>, which prefers sunny banks, was identified.</p>

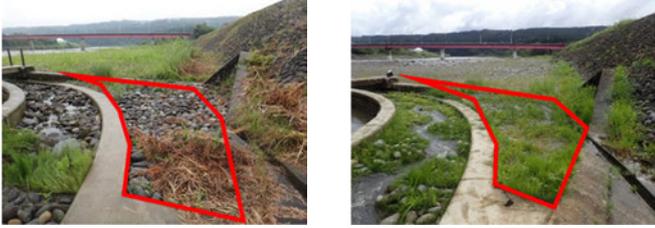
<p>Area 5 (12 m²): In 2014, woody plants, such as <i>Zelkova serrata</i> and <i>Salix gilgiana</i> disappeared due to floods. The vegetation became denser due to sedimentation from the 2019 and 2020 floods. The important species <i>Galium gracilens</i> disappeared and <i>Cyperus glomeratus</i> was confirmed.</p>

Area 5 outside the rock-ramp fishway had a rocky substrate adjacent to the upstream turn-around section in 2014. However, by 2020, the accumulation of sediment facilitated the growth of plants. Previously, moist and uninhabitable dry environments were present, but after the 2019 flood the entire environment was disturbed and became moist; in this area, the number of confirmed species of plants was relatively high. In addition, on the revetment on the right bank side (Area 4), a colony of *G. gracilens* was confirmed. In Area 4, several *C. lanceolata* and *S. sarmentosum* were growing in 2013 and 2014, but in 2020 *C. lanceolata* was not confirmed and almost all of the masonry was visible. In Area 4, gaps between logging and masonry were filled with mortar as part of maintenance. These changes in the habitat made it easier for *G. gracilens*, which grows on sunny banks, to establish, which may have contributed to the disappearance of woody plants.

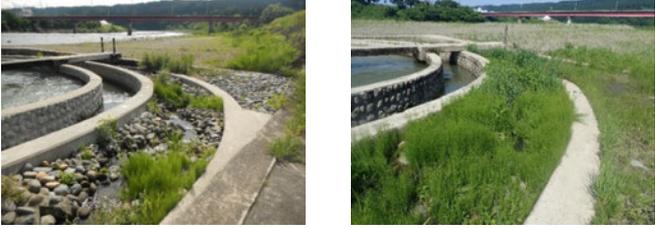
<p>2014 Summer 2020 Autumn</p>	<p>Area 6 (20 m²): Many plants grew, including <i>Equisetum arvense</i> and <i>Persicaria lapathifolia</i>. Owing to the sedimentation caused by the flood in the summer of 2020, large herbs and <i>Galium gracilens</i> and <i>Veronica undulata</i> disappeared and the annuals <i>Echinochloa crus-galli</i> and <i>Persicaria hydropiper</i> dominated.</p>

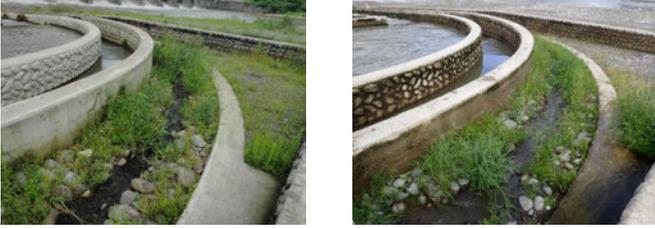
<p>2014 Summer 2020 Summer</p>
<p>Area 7 (50 m²): A large number of species were confirmed throughout the survey period. <i>Salix jessoensis</i> was identified in 2013, but it was not confirmed in 2014 and <i>Juglans ailantifolia</i> grew. Due to the flooding of 2020, <i>Phalaris arundinacea</i> decreased. Instead, <i>Echinochloa crus-galli</i> formed a community.</p>

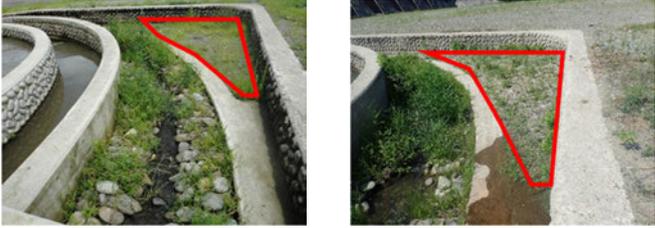
<p>2013 Summer 2020 Autumn</p>	<p>Area 8 (12 m²): Annuals such as <i>Digitaria ciliaris</i> and <i>Conyza sumatrensis</i> grew in the wastelands, and <i>Melilotus albus</i> was observed. Most species emerged in 2014. <i>Persicaria lapathifolia</i> grew densely in damp places, and young trees of <i>Ailanthus altissima</i> were found. One <i>Cyperus glomeratus</i> was confirmed.</p>

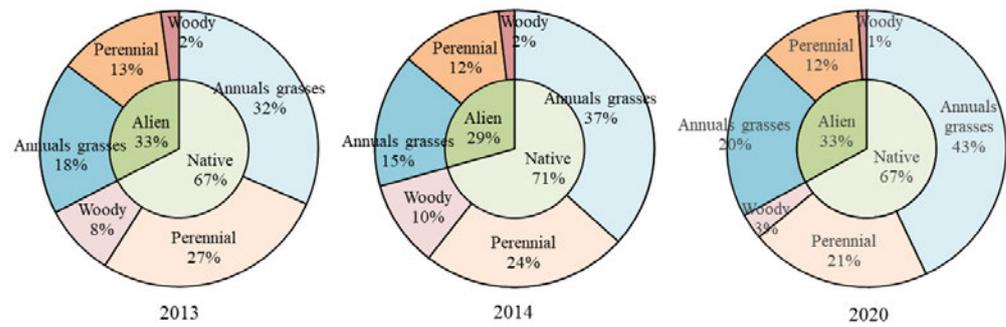
Figure 6. Confirmed species in 2013, 2014, and 2020. Confirmed plants were classified into native and alien species, which were then divided into annuals, perennials, and woody plants.

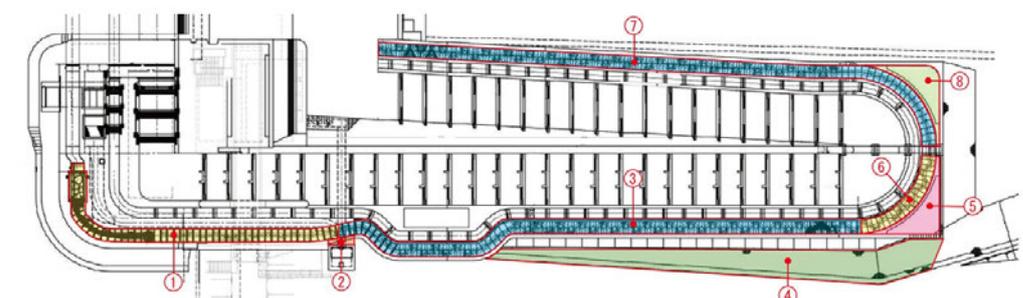
Figure 7. Vegetation coverage divided by 25% for each area. Data were divided into underwater sections and cobblestone gaps beside the main stream. Areas outside the fishway (2, 4, 5, and 8) and in 2016 without aerial photographs are excluded.

Figure 7 shows the calculated results of the vegetation coverage. The vegetation coverage rate is an index value, with “10 or less” indicating less than 10% coverage, “10–25” indicating 10–25% coverage, “25–50” indicating 25–50% coverage, “50–75” indicating 50–75% coverage, and “75 or more” indicating 75–100% coverage. The vegetation coverage of underwater sections did not change significantly in any area, while vegetation coverage in the Cobblestone gap in Areas 1, 3, and 6, which are relatively unaffected by flooding, showed an increasing trend. However, the vegetation coverage in the Cobblestone gap in Area 7 varied significantly because of floods.
