New Visual Inspection System of Rolling Stock Underside by Image Processing Technique

●**Keywords:** Rolling stock, Underfloor equipment inspection, Image processing, Line camera

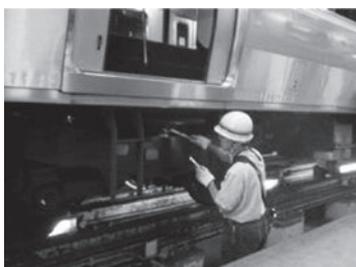
Fig. 1 Inspection Work for Underfloor Equipment

Conventionally, underside inspection of rolling stock (confirmation of attachment to body, presence of deformation, etc.) is done by human eyes. There are more than 100 locations to be inspected per car, and those are very diverse, covering areas such as bogies, equipment boxes, bolts, and inspection cover handles. Many inspection experts are needed to perform those inspections, and a broad range of knowledge and experiences is demanded of them. Moreover, work is done on equipment under floors, so inspection pits are required to perform that work.

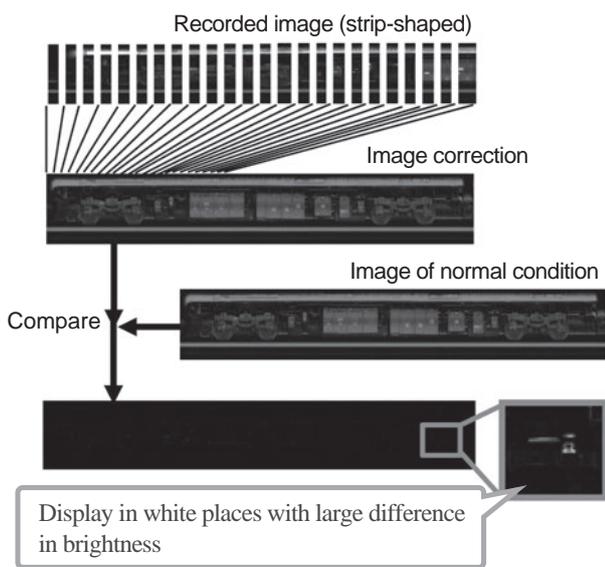
Fig. 2 Flow of Image Processing

- (a) Record images of underside of rolling stock running at 25 km/h or less by line scan camera*.
- (b) Correct brightness that differs according to time of recording for strip-shaped images recorded by the line scan camera. Merge images to create an image for one car, and then compensate for stretch from speed (sudden acceleration or braking) when the car is running and effects of vibration and the like (Fig. 2).

- (c) Perform the following processing by software for the image of (b), above. Extract edges of equipment from the difference in brightness of adjacent pixels and compare with edge brightness of “normal” rolling stock registered in advance.

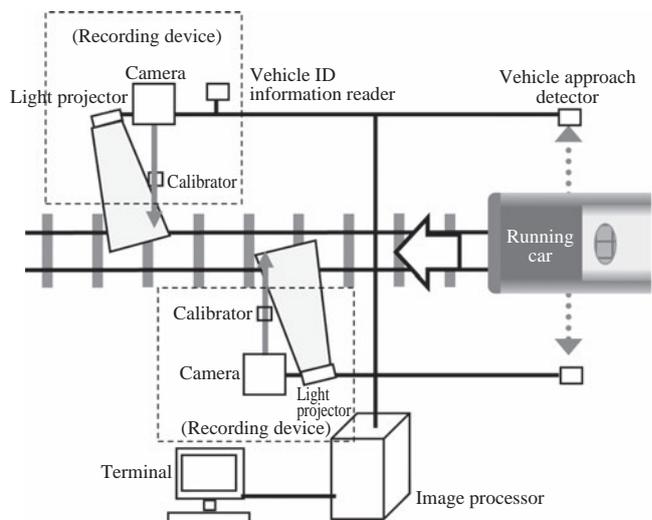
Fig. 3 System Configuration

This system is composed of a recording device (camera and light projector), image processor, terminal, vehicle approach detector, and vehicle ID detector (Fig. 3).

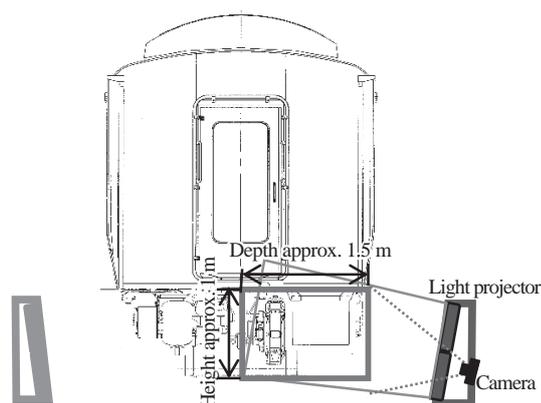
Fig. 4 Overview of Recording Device

Fig. 4 shows the positional relationship of the camera and light projector and the vehicle. Lighting needs to shine evenly on the multiple objects to be inspected in order to perform judgment processing by accurate and stable images. In this development, we decided on the camera and light projector position and angle by brightness simulation and installed those so brightness is of the appropriate value on the line that the camera records in each section in a direction parallel to the sleepers (Fig. 5).

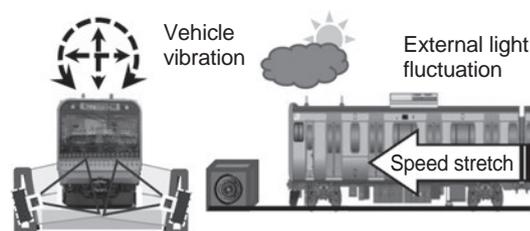
Fig. 6 Factors that Affect Image

In designing the algorithm, (a) correction of brightness in relation to outside light and (b) elimination of the effect of rolling stock speed change and body and bogie vibration due to running are major points. The following introduces details of our efforts.

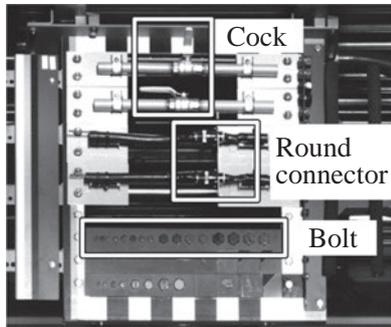
Fig. 8 DMockup Used for Verifying Abnormality Detection Performance

A temporary structure (Fig. 8) simulating abnormalities such as bolt and round connector looseness and equipment box inspection cover handle rotation was equipped under the floor of a vehicle, and test runs were made to pass by the system and verify abnormality detection performance.

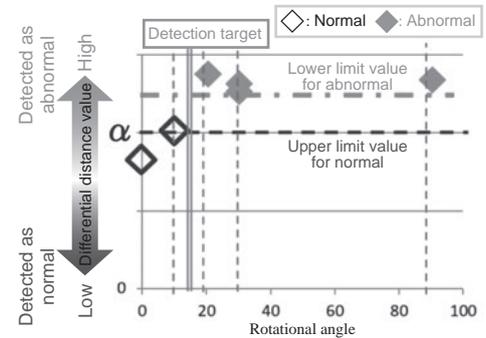
Fig. 9 Change in Differential Distance Value when Angle of Equipment Box Inspection Cover Handle Changed

Fig. 9 shows an example of verification for an equipment box inspection cover handle. We found that the differential distance value changes when handle rotation angle is changed. We have set the abnormality detection target for the handle to be "displacement of 15° or more", and detection of abnormalities is possible by defining the differential distance value threshold from change in differential distance value when degree of abnormality is changed. And by setting threshold values similarly for cocks, round connectors, and bolts, we achieved the anticipated targets as shown in Table 1.

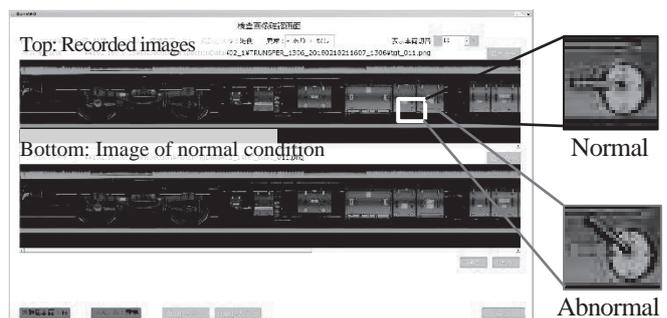
Fig. 12 Inspection Image Confirmation Screen

terminal (Fig. 11). When an abnormality is judged to be present, an image of that and an image of normal condition are displayed for inspection experts to compare and confirm visually the actual status of the rolling stock (Fig. 12).
