## Our measures against earthquakes

### Damage by the Great East Japan Earthquake (Tohoku-Pacific Ocean Earthquake)

### Damage and restoration of railway related facilities following the disaster

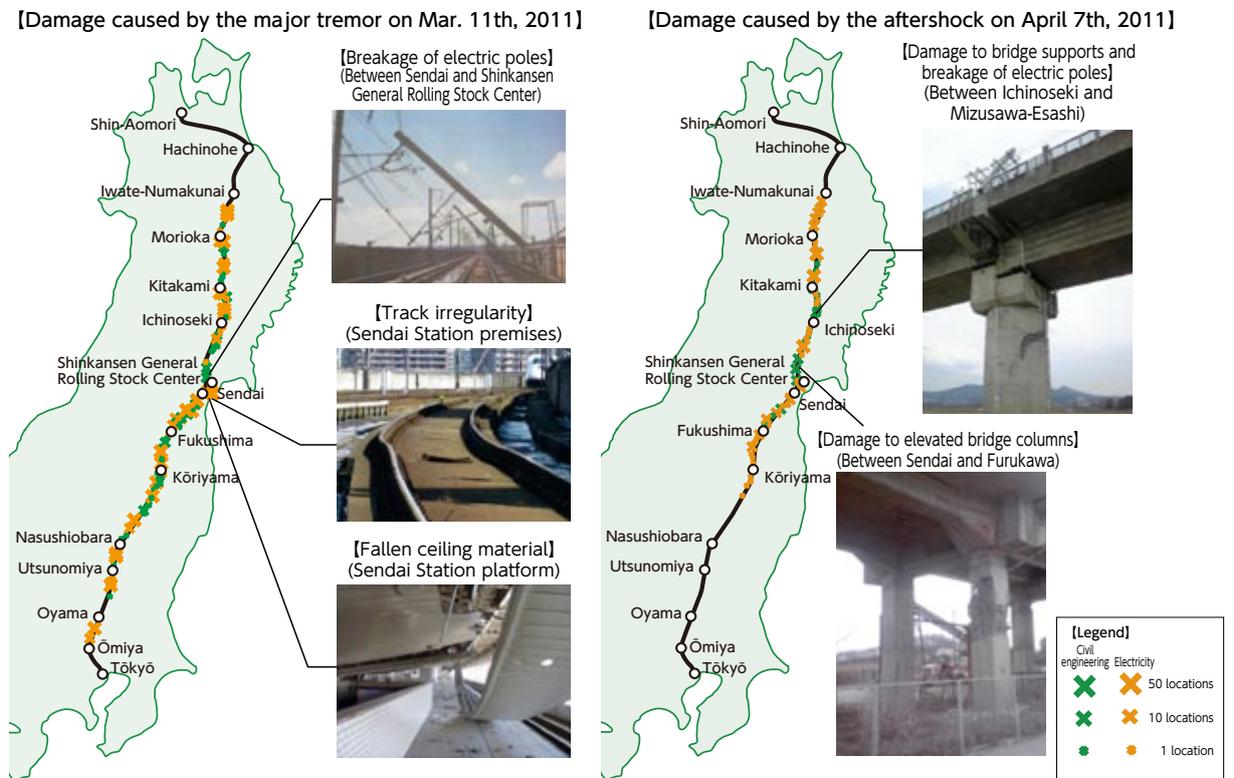
#### <Major damage to ground facilities for Tohoku Shinkansen>

The Great East Japan Earthquake resulted in profound damage to our railway facilities, including the ground facilities for both the Shinkansen and conventional lines. The following chart outlines the damage incurred by our railway facilities due to the earthquake.

\* There was no collapse of elevated bridges, bridges, station buildings, or tunnels.

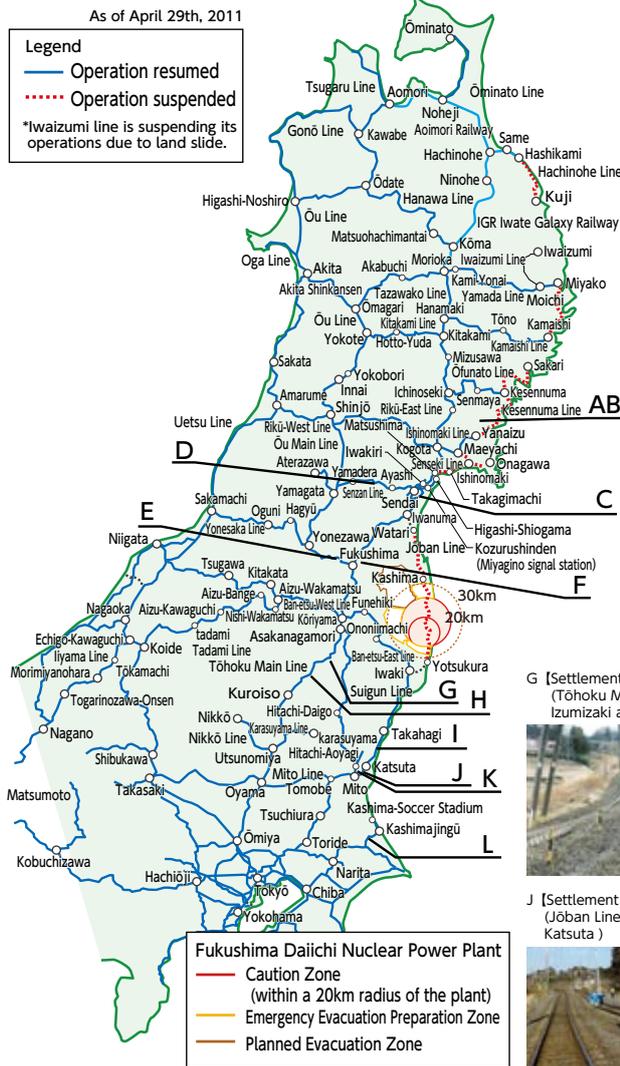
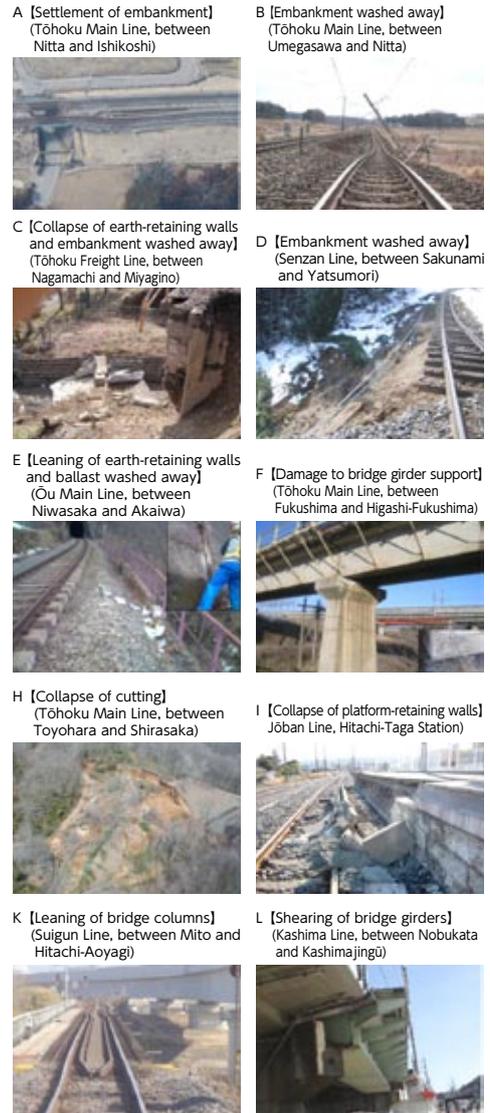
### <Major damage to ground facilities for conventional lines>

\* Major damage to ground facilities on 7 railway lines resulting from the tsunami not included.

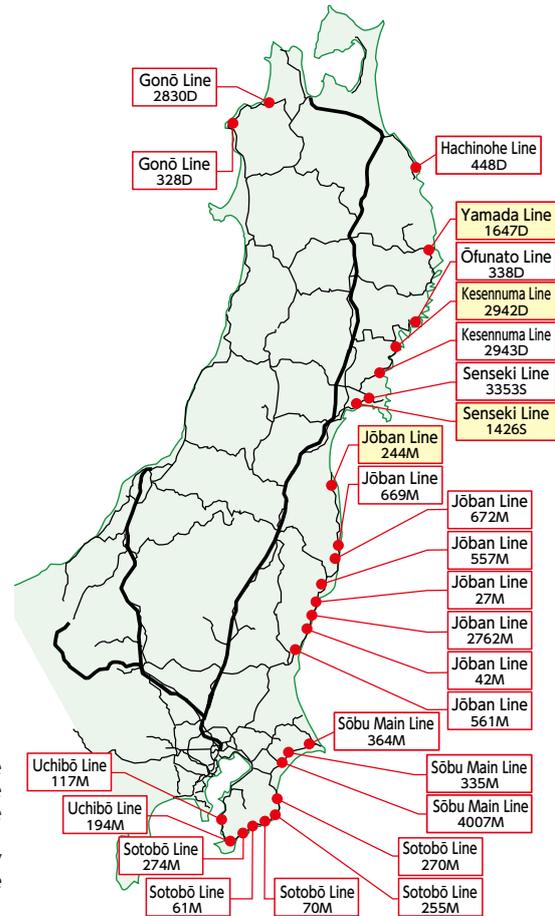
At the time of the earthquake, trains were evacuated to prepare for the tsunami. (\*Trains washed away by the tsunami are indicated in yellow.)

At the time of the earthquake, we evacuated customers from 27 conventional line trains at stations or between stations, and from 34 stations. After the evacuation, five trains were derailed and washed away by the tsunami. However, through the concerted efforts of train crews, station personnel, and dispatchers as well as with the cooperation of customers on board trains and neighboring communities, we were able to safely evacuate our customers and there were no customers hurt by the tsunami at stations or on board trains.

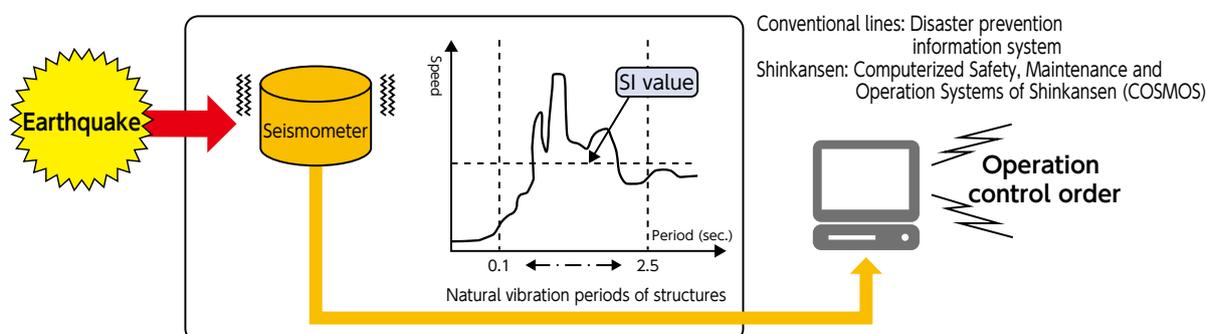
As for operational restrictions for an earthquake, since April 2003 for conventional lines, and since Sep. 2005 for Shinkansen, JR East has been utilizing spectrum intensity (SI value, kine: cm/sec), which is highly relative to damage to structures.

With SI values, JR East is able to take the duration of acceleration force and natural periods of vibration for each structure into consideration to increase the accuracy of its prediction of damage to structures, which was not possible with traditional methods that utilize maximum acceleration (gal: cm/sec<sup>2</sup>).

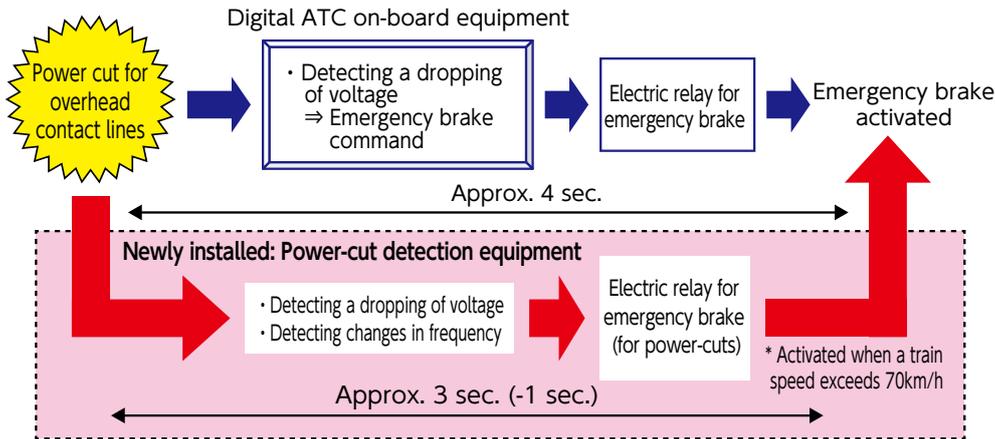
For Shinkansen, when a wayside seismometer detects the occurrence of an earthquake, the power supply to overhead contact lines is shut off to stop Shinkansen trains. In addition to on-board digital ATC equipment detecting the power cut to the overhead contact line and activating emergency braking, JR East has newly installed power-cut detection equipment to shorten the time required for the detection by approx. 1 sec. to quicken the emergency braking.

Moreover, for E5 and later series of Shinkansen trains, when the power-cut detection equipment activates the emergency brake, an improved braking system can stop the trains with less braking distance by applying stronger braking.

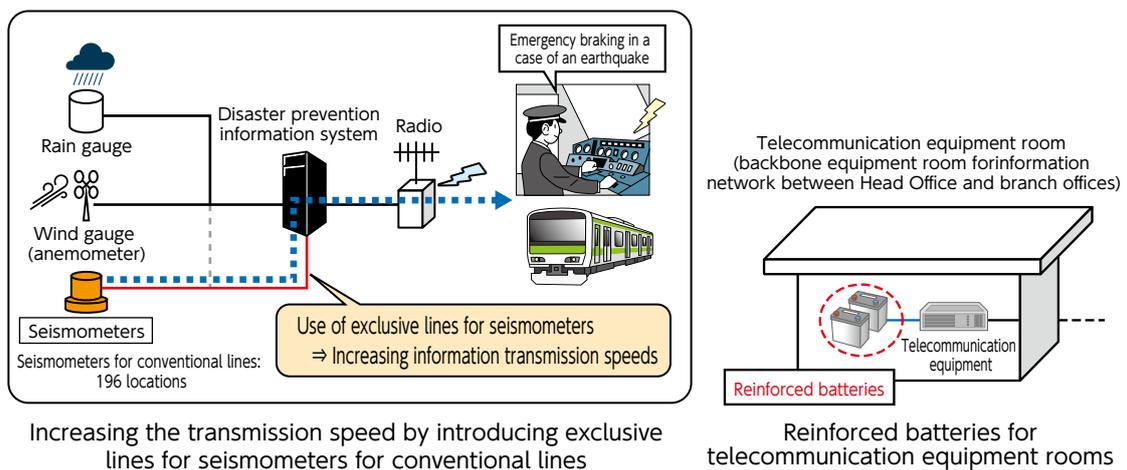
JR East is increasing the transmission speed of earthquake observation values for conventional lines. At the time of the Great East Japan Earthquake, the power supply was cut for a long time over a wide area and we could not use telecommunication facilities. For this reason, JR East has reinforced telecommunication facilities by strengthening the battery capabilities of telecommunication equipment rooms to 48 hours and by installing emergency outlets for telecommunication equipment in buildings.

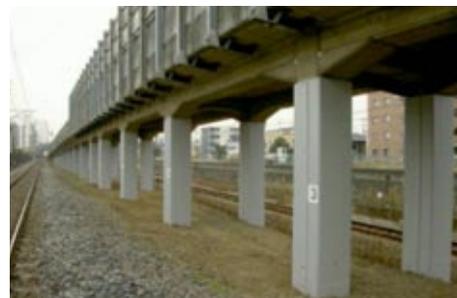
Seismic reinforcement of elevated bridge columns by steel plate wrapping

Currently, we are reinforcing elevated bridge columns susceptible to failure due to bending by strong earthquake motion for Shinkansen and conventional lines in the Southern Kanto and Sendai areas. For some section of conventional lines in other areas, we are reinforcing elevated bridge columns and bridge columns susceptible to shear failure.

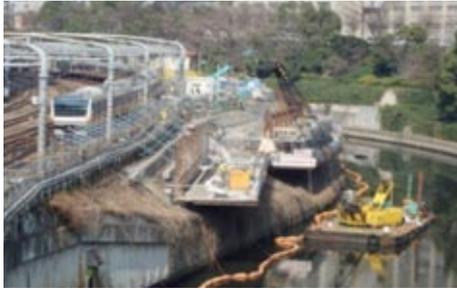
**■ Reinforcement examples for an earthquake directly beneath the Tokyo metropolitan area**

Seismic reinforcement of embankment

Based on the Great East Japan Earthquake and to ensure we are prepared for an earthquake directly beneath the Tokyo metropolitan area, we are proceeding with seismic reinforcement of embankments, cuttings, and brick arched elevated bridges for nine railway sections (approx. 220km) including the Yamanote and Chuo Lines. We will also continue our efforts to complete the seismic reinforcement of bridge columns ahead of schedule.

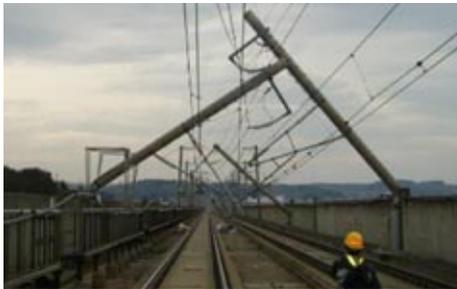
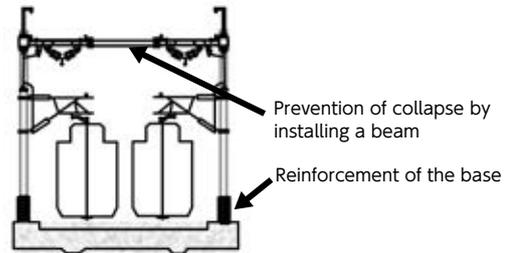
**■ Electric poles damaged by the Great East Japan Earthquake and reinforcement (image)**

**[Reinforcement of electric poles and installation of a beam to make it a gate shape]**

We have also reinforced approx. 2,300 electric poles damaged by the Great East Japan Earthquake on Shinkansen and conventional lines.

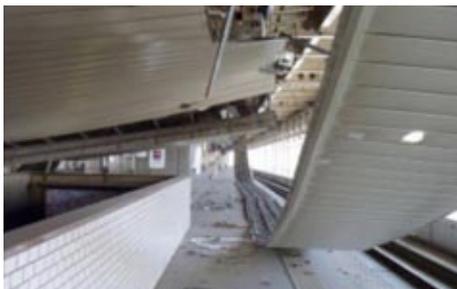
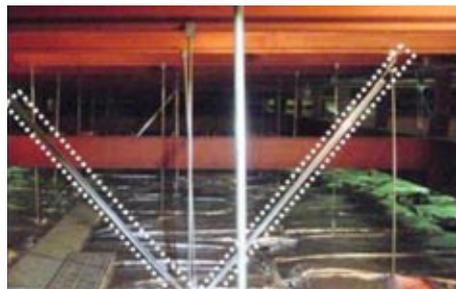
**■ Fallen ceiling material due to the Great East Japan Earthquake and reinforcement by diagonal bracing (image)**

For station buildings and platforms, we will continue our measures to prevent the collapse of ceilings for approx. 560 stations and of walls for approx. 60 stations.

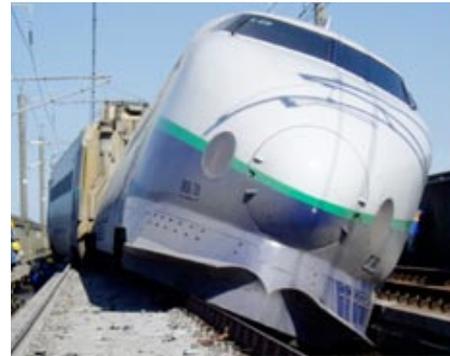
Joetsu Shinkansen trains, Toki No.325

During the Niigata Chuetsu Earthquake in 2004, one of our Joetsu Shinkansen trains, Toki No. 325, derailed. Based on an investigation of the causes of the derailment, JR East has taken measures such as those described below. At the time of the Great East Japan Earthquake, a test Shinkansen train derailed at low speed. Learning from the results of the investigation of Shinkansen rolling stock and tracks, JR East continues its efforts to further improve its safety measures.

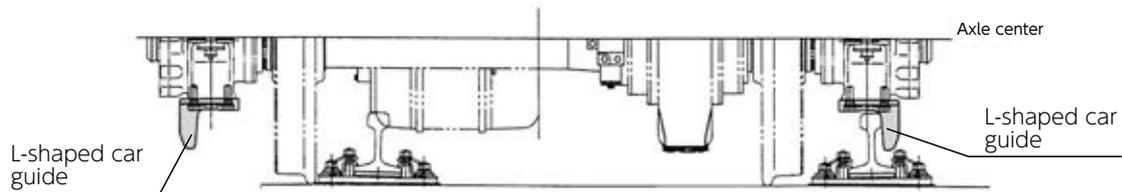
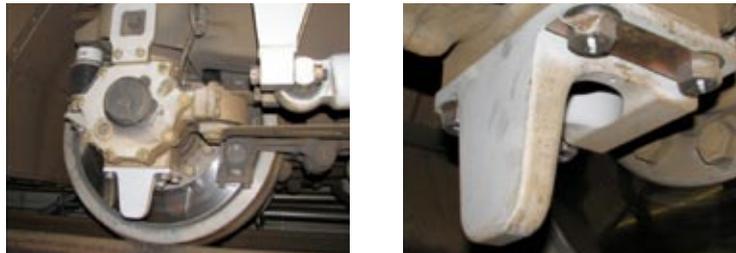
L-shaped car guide

L-shaped car guides are installed on bogies to prevent Shinkansen trains from completely leaving the track in a derailment. We had completed the installation of L-shaped car guides for all Shinkansen by Aug. 2008.

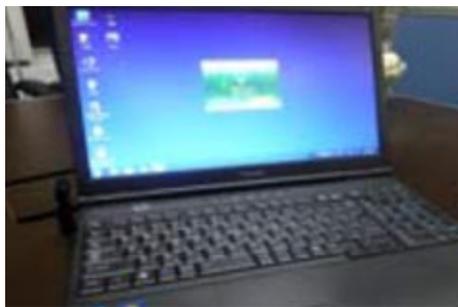
WiMAX terminals

To prepare for disruption in commercial data communication via the in-house intranet, as substitutes we installed WiMAX terminals capable of data communication at Head Office, branch offices and major stations in Dec. 2012.

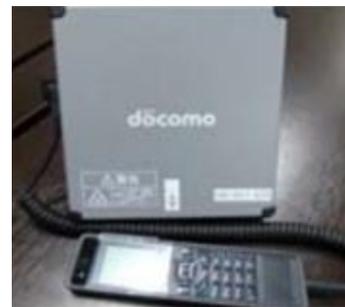
Satellite mobile phones

To prepare for the wrecking of antenna and cables, we have installed satellite mobile phones at Head Office, branch offices and major stations to prevent damage to ground facilities affecting secure commercial communication in Aug. 2012.

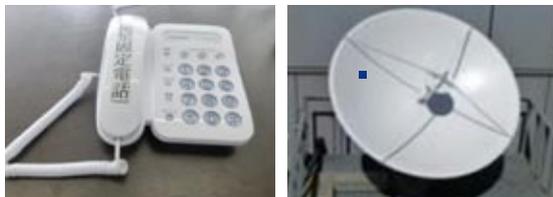
Satellite fixed phones

To prepare for disruption of communication due to physical damage or communication limits, we installed satellite communication facilities capable of commercial audio and data communication via exclusive lines at Head Office, and at Tokyo, Yokohama, Hachioji, Omiya, Takasaki and Chiba branch offices in Mar. 2013.

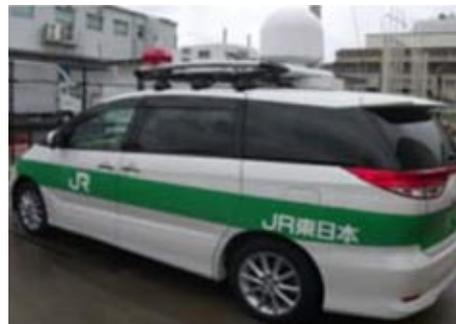
An automobile with on-board satellite communication facilities

At Yokohama and Omiya branch offices, we installed satellite communication facilities into automobiles in Mar. 2013, equivalent to those installed at other branch offices.
