Improvement of safety equipment

Investment in safety equipment for “extreme safety levels”

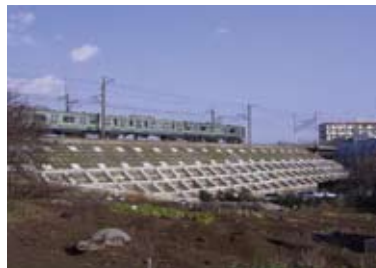
JR East has completed its planned reinforcement work to railway lines to protect against heavy rainfall. The measures are intended to reduce operational restrictions due to heavy rain and minimize any effect on train operations. JR East began reinforcement work for disaster prevention against rainfall in April 2004 on 12 routes, mainly in the Tokyo metropolitan area and with high levels of traffic, with the work being completed in June 2008.

Concrete lattice frame protection work

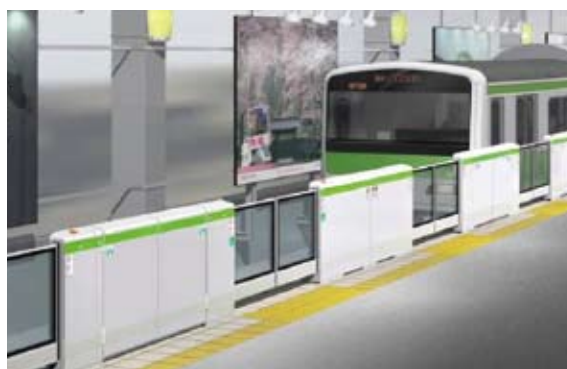
In response to increasing customer expectation and demand for higher levels of platform safety, JR East will introduce automatic platform gates on the Yamanote Line. The gates will initially be installed in Ebisu and Meguro Stations of the Yamanote Line by the end of March 2011 and, after verifying technological issues and the effects on train operations in coordination with other large-scale improvement work, we hope to complete the introduction of these gates to all stations on the Yamanote Line near the end of March 2018.

Automatic platform gates on the Yamanote Line (image)
